# **RIVER TRAINING STRUCTURES IN THE BRAHMAPUTRA RIVER IN BANGLADESH, COMPARISON OF SCOUR, STUDY AND NATURE**

## **ABSTRACT**

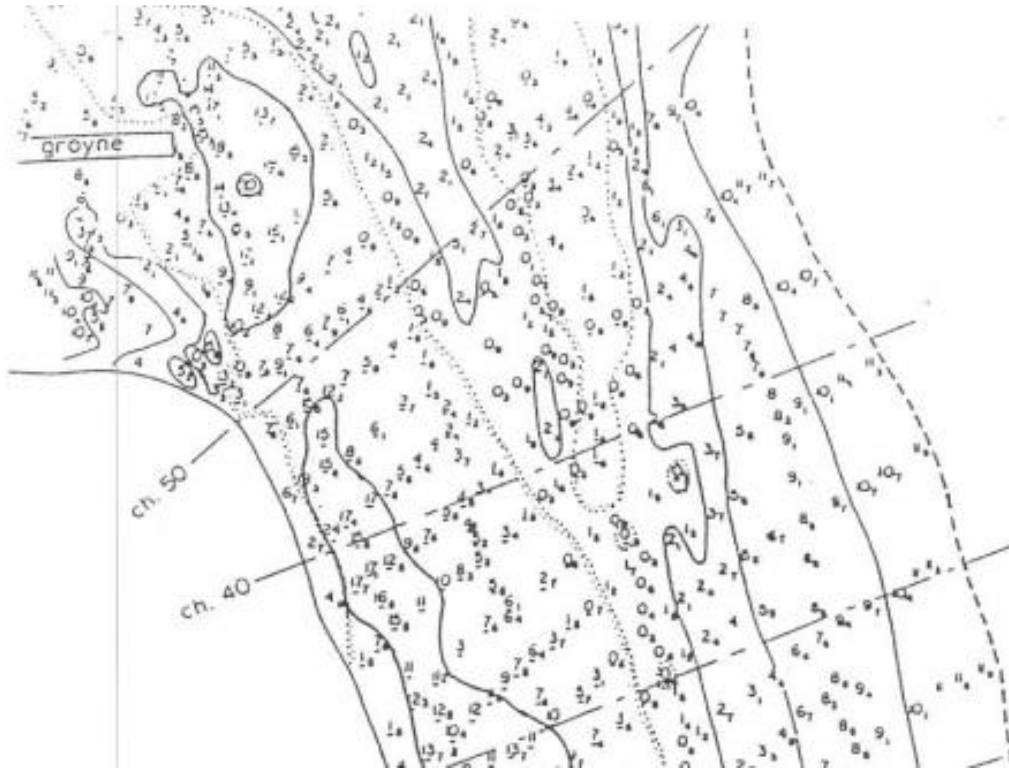
Figure 3 River survey at Sirajganj, 1986. Note the Ranigram Groyne to the north (groyne).

The value of  $\alpha$  is 0.85 which is about 30 per cent below the value of 1.10, found by Liu's formula. For the March '91 situation, the scour is less, probably because these measurements were performed towards the end of the dry season. It was assumed that such scour holes can develop in a period of a month or two depending on the flow velocity and thus the sediment transport capacity. This is also documented by the fact that Ranigram groyne was built in 1985 and already in August '86 after one year the very deep scour hole had developed at its nose.

It is further of interest to note that the distance from the head of the groyne to the Aug '86 scour hole was about 200 m and that the difference in level over the outer 150 m was about 25 m, i.e., a slope of about 1:6 of the riverbed towards the scour hole.

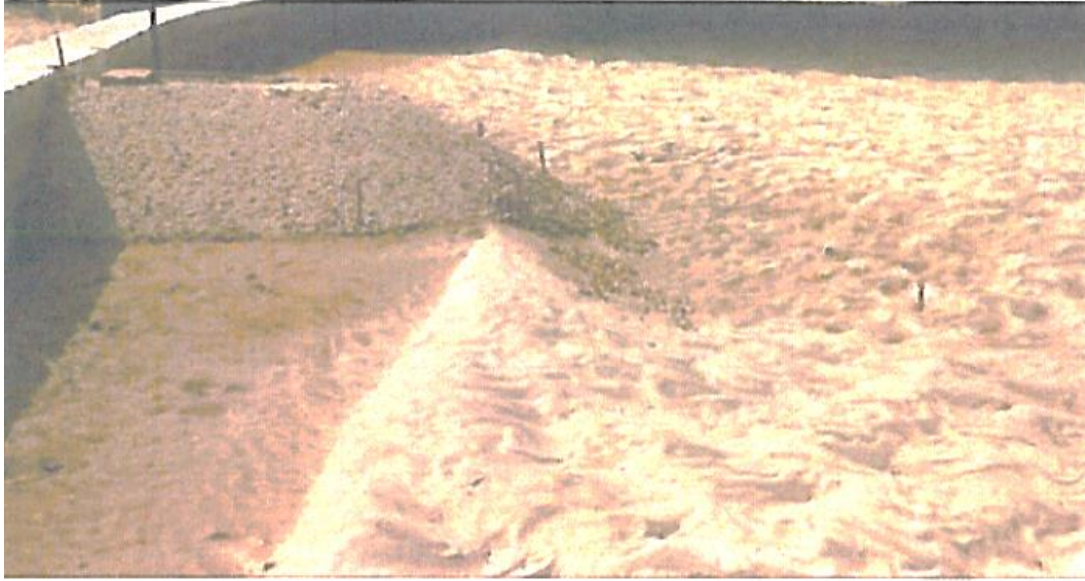
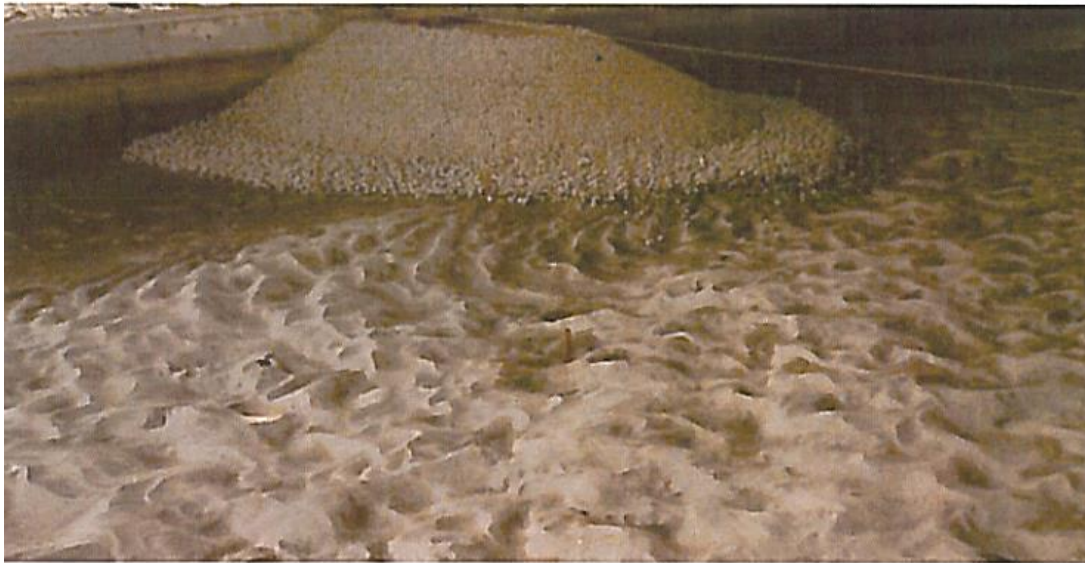
Figure 8 (1) Model tests of groyne, sloping structure with no apron. Scour 13.3 m (67% of depth)  
(2) Model tests of groyne, sloping structure with toe apron. Scour 8.6 m (43% of depth)

The test results (Figure 8) and prototype observations for groynes with side slope show some scatter. The coefficient,  $\alpha$ , was found to be about 0.85 from the field observations, about 0.80 in the distorted model test for Ranigram Groyne, and 0.72 in undistorted model tests.

It is further evident that in most cases, the deep scour hole is located away from the structure. Only in Model 17 was the scour hole close to the toe of the structure. The maximum scour was 20.5 m and the maximum scour at the toe 18.0 m. The latter value of 18.0 m corresponds to a value of  $\alpha$  of 0.63.

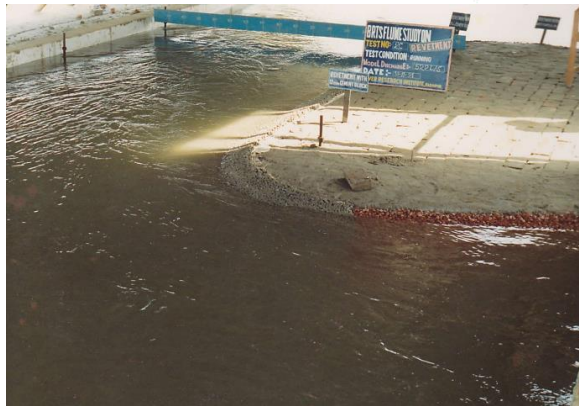
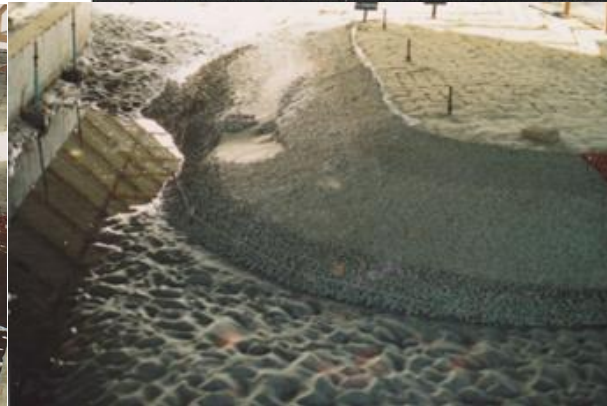
Figure 10 Model set up. Results of stability tests and photos during tests and after with damage

The stability of the armour layer blocks as function of the local flow velocity is shown in Figure 10 together with the adopted design formula for stability of armour blocks in current. The formula is denoted JMBA equation in Ref. /6/. It is the Izbash formula, that was later on updated to be more generally applicable by Pilarczyk. The results in Figure 10 also shows for a typical situation the velocity distribution near the structure, and a flow induced failure of the armour layer in the straight section just adjacent to the upstream termination.

Another important finding of the model study was that heavier armour is required near the upstream section than on the rest of the structure.

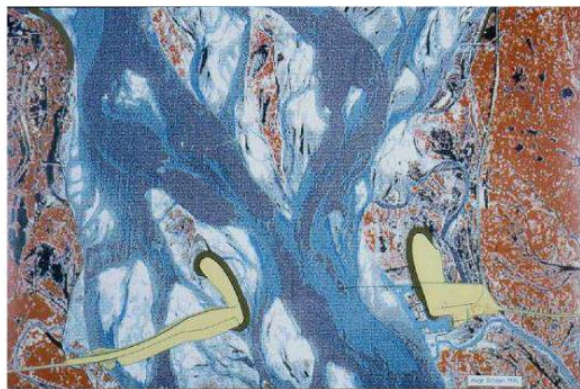
Figure 4: Revised layout of Jamuna Bridge guide bunds as built
