Alderney Breakwater, a developed rehabilitation solution

Ole Juul Jensen, COWI A/S, Kgs. Lyngby, Denmark Arne Bisgaard, COWI A/S, Kgs. Lyngby, Denmark Hugo Wood, COWI UK Ltd., London, UK Nadia Genovese, COWI UK Ltd., London, UK

Abstract

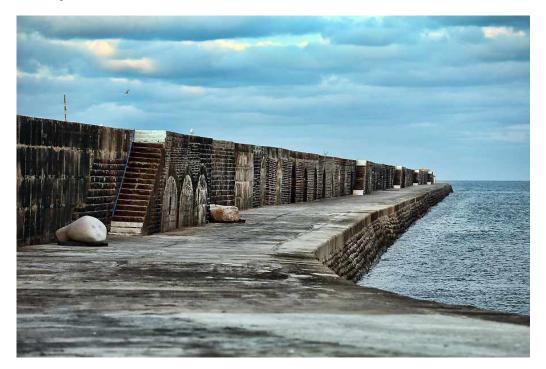
Figure 2 Alderney Breakwater roadway and rear-side of wave wall (Courtesy Adrian Findlay – from: http://www.findlays.net/photo/clonque-12-02/index-all.html)

The photo in Figure 2 gives a good impression of the overwater part of the breakwater and the construction technique using masonry that was common at that time before the introduction of concrete. Figure 3 shows a typical cross section of the existing and the proposed upgraded breakwater. Figure 4 shows the seaward side and how the breakwater is exposed to waves impinging on the front and causing run-up and overtopping even for relatively small waves, as on the day the picture was taken. In severe storms very severe green water overtopping occurs over the entire breakwater length.

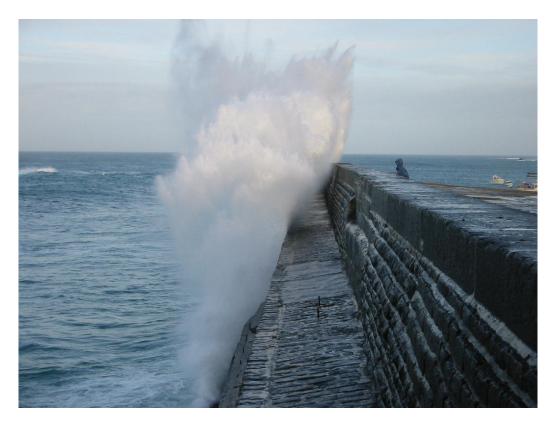
Figure 4 Front-side of the breakwater (Courtesy Adrian Findlay – from: http://www.findlays.net/photo/clonque-12-02/index-all.html)
