# **Safety of Breakwater Armour Layers with Special Focus on Monolayer Armour Units**

## **(Discussion Based Upon Four Decades Experience of Breakwater Damage)**

**Ole Juul Jensen** Director, Marine and Coastal Engineering,  
COWI A/S, Denmark (From 1975 to 1994, Danish Hydraulic Institute)

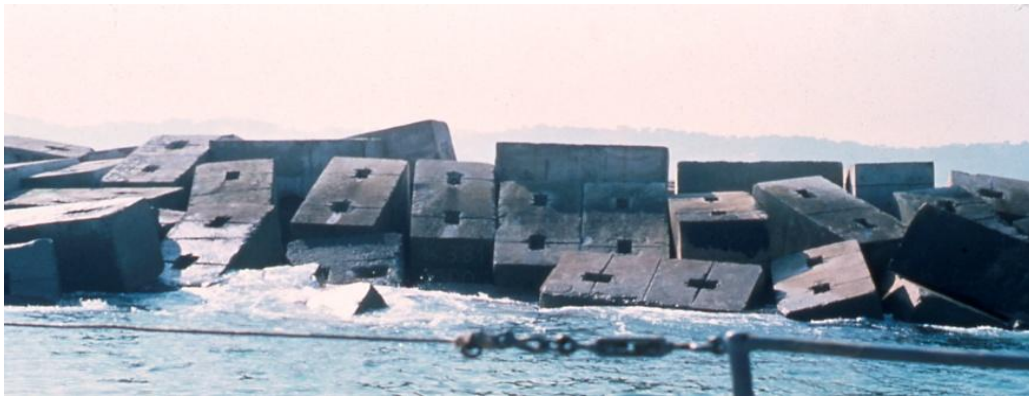
Figure 1 Example of breakwater built in the 1930'ies and armoured with large rectangular blocks.

Designers of breakwaters have since the 1930'ies relied upon an estimation of waves at the site and the use of empirical formulae for the determination of the size of armour units. In many cases it was also on a "trial and error" process, where the breakwater was designed based upon limited knowledge about the wave conditions, which in many cases resulted in a too weak design. The breakwater was then repaired after damage and hence it became stronger and stronger. Some of the earlier breakwaters with artificial units were armoured with cubes or rectangular blocks and as for rock breakwaters; the repair is often relatively easy, as it can be done by adding more armour units for reinforcement and strengthening. One example of such blocks from 1930'ies is shown in Figure 1.

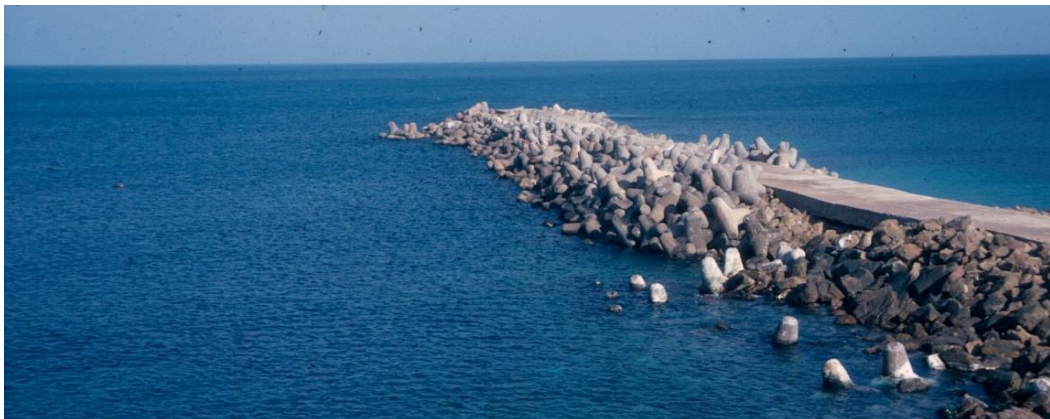
Figure 2 Damaged tetrapod breakwater in El Kala, Algeria.

In the 1950'ies the use of the new armour unit, Tetrapod, took off and many successful projects were implemented. However, breakwater damage occurred for also with Tetrapods. An example from around 1979 is shown in Figure 2.

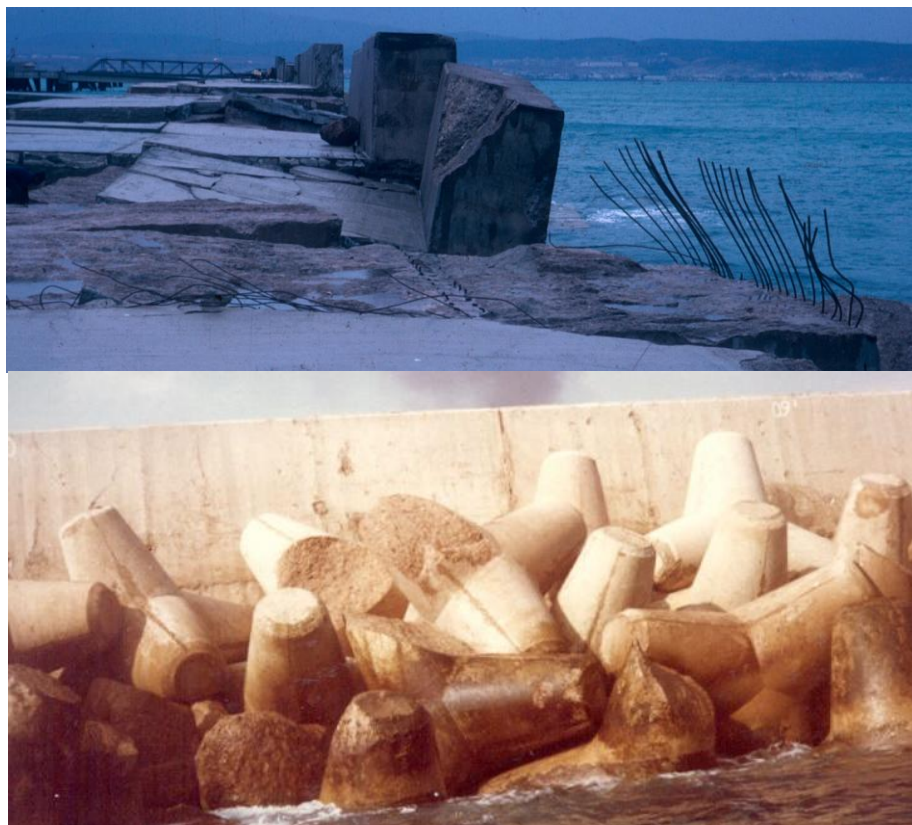
Figure 6. Although the breakwater is in the same water depth for its entire length and should be exposed to almost the same wave impact, the damage was varying along the breakwater trunk and also the roundheads were severely damaged. The total displacement of the armour layer in many sections lead to undermining of the very heavy and 4m thick superstructure, which was also heavily damaged, see Figure 6. Subsequent model test investigations showed that the breakwater armour layer must have been constructed with a relatively high porosity and loose packing density and that the wave impact during the storm led to compaction and settlements of the entire armour layer, see (Abdelbaki & Jensen, 1983). This must have led to the breakage of the units and hence the loss of interlocking and failure of sections of the armour layer. For  $H_s=7\text{m}$ , the corresponding  $K_D$  is as low as 5.5; so this would be regarded as safe at the design stage. It is interesting to compare with the breakwater in Figure 2, where some of the  $4\text{m}^3$  Tetrapods had rolled shoreward over the rock armour without breaking, while most of the  $10\text{m}^3$  units broke after having been exposed to the same rolling.

Figure 6      Photos of Arzew el Djedid breakwater damage. Above, most damaged sections and below, section with settlement of entire armour layer and broken units.

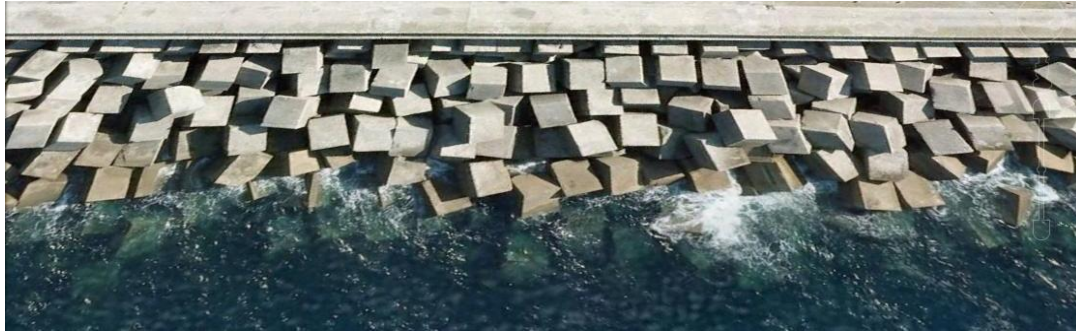
Figure 8 The armour layer on the Bilbao Breakwater 2013 (Google Earth).

Long and detailed studies followed and the breakwater was repaired using the same type of armour units, large rectangular blocks, but larger than before and on a flatter slope of 1:2. Furthermore, a proper berm was introduced at a lower level and finally the superstructure was made heavier and it projected less above the armour and would thus be less exposed to large wave impacts, see (Jensen, 1984) for further details of these studies. Figure 8 is a present Google Earth photo of the armour layer in front of the largest oil berth. The armour layer looks intact but possibly with a few spots where blocks might have been displaced.

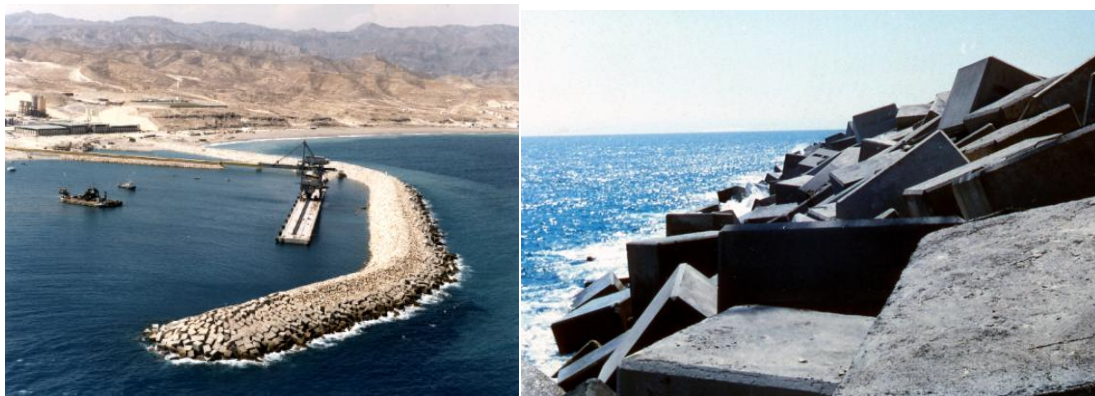
In 1981 after some of the major failures described in this paper had become common knowledge to the profession, the author got involved in the studies for a new port in Spain, Puerto de Carboneras. The breakwater protects a berth for the import of coal for the power plant seen to the left on the photo in Figure 9. At that time it was clear that there was doubt about the use of both Dolos and Tetrapods for such major breakwaters. The design wave height was about the same as for the Arzew el Djedid in Algeria on the other side of the Western Mediterranean. The author, the team at DHI and the designer, Christiani and Nielsen – Copenhagen developed a new concept shown in Figure 9.

Figure 9 Puerto de Carboneras Breakwater. Cross section in deep water and photos of the port and armour layer.

First, it was clear that the breakwater had to be separated from the traffic and the conveyor belt from the berth. Therefore, contrary to other breakwaters nearby, the breakwater was developed as a pure rubble mound structure without a superstructure. As rock could be quarried in the mountains nearby, it was relatively cheap, but the size which could be obtained in large quantities was limited to 2-4 t. Therefore the crest of the breakwater on the major deep water section was made in such high level of +13.5m, that 2-4 t rock could be used on the crest and rear side of the breakwater. Model tests proved

that the transition from the main armour of 58t rectangular blocks to the rock could take place at level +10m. There are two berms on the breakwater, the upper with 2-4 t rock and the lower outer/lower placed directly onto the sand sea bed with 0.2-2 t rock. The outer berm/toe is allowed to sink into the bed and form a solid foundation for the upper berm that has a 2m thick layer of quarry run underneath. The relatively small stones of 0.2-2 t were also used as filter under the 58t armour units. Model tests in 2D and 3D were used for design verification and to the authors knowledge the breakwater has now been in successful service for 30 years. This is verified by the Google Earth pictures available on the Internet.

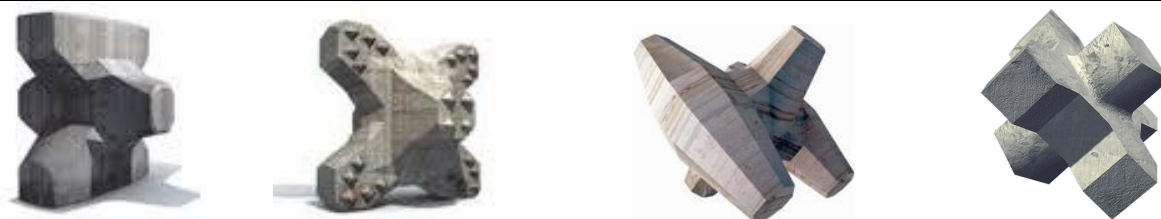
Figure 12 Comparison of monolayer breakwater armour units: Accropode I, Accropode II, Core-Loc and Xbloc.

Since the introduction of the Accropode as the first monolayer unit in 1981 followed by the other types of monolayer systems, several hundreds of applications have been constructed. Many successful projects have been made, but in some cases problems have occurred. The patentees and promoters claim in their material that  $K_D$  values as high as 15 or 16 applies for mild sea bed slopes (see Figure 12 below), and that model tests shall be carried out for final verification.

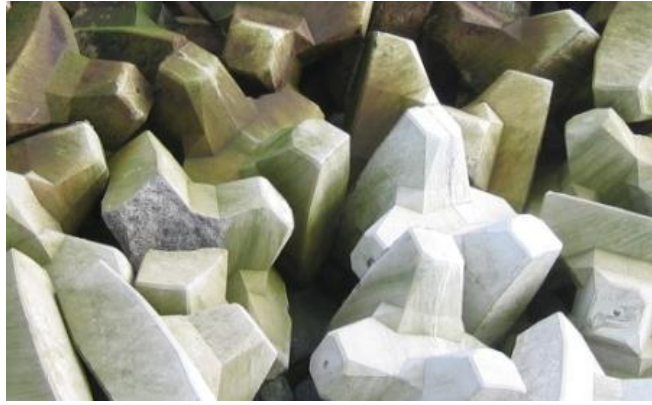
Figure 13 Example 1: Accropode breakwater with approx.  $K_D=15$  after exposure to design event. Note broken units and openings, non-interlocking units.

Also monolayer armoured breakwaters have suffered damage, and it appears that the stability factors and procedures previously used are in some cases not leading to safe and robust designs. It is clear that until now, the damage occurring to these projects is less severe than what was experienced previously in Spain, Portugal and Algeria, and shown in the examples above. But it is however worrying for our profession, that there still today seems to be a fierce competition to minimise the size of armour units. The examples, from nature and practical applications, shown in Figure 13 and 14 are visualising that more safety has to be built into such breakwaters.

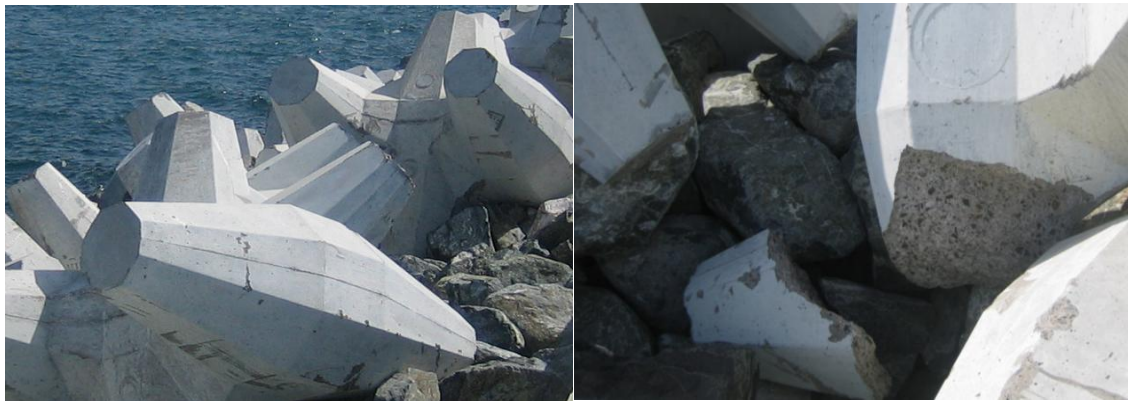
Figure 14 Example 2: Core-Loc breakwater with approx.  $K_D=16$ . Note settlement of entire armour layer creating gap at wave wall and some breakage.
