# SAFETY OF MONOLAYER BREAKWATERS

*O. Juul Jensen<sup>1</sup>, L. Uguccioni<sup>1</sup> and T. Gierlevsen<sup>1</sup>*

*<sup>1</sup>Department of Marine and Foundation Engineering, COWI A/S., Denmark*

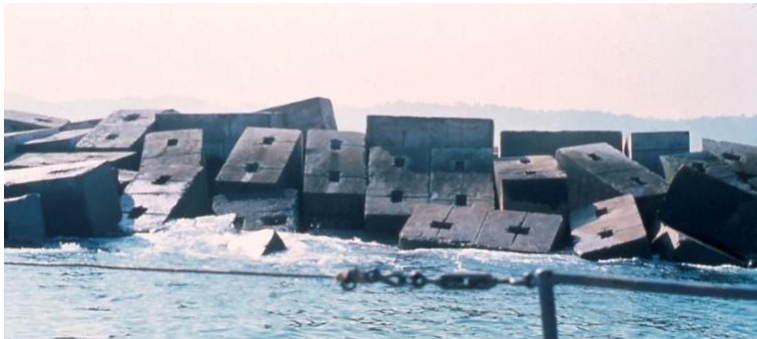
The design of rubble mound breakwaters has since about 150 years ago and until the 1930's mainly relied on practical experience and "trial and error" procedures and the use of quarry rocks and concrete armour units like cubes or elongated cubes/rectangular blocks as armour. In the 1930s the approach became more scientific with further development of the understanding of ocean waves and the relationship between the wave height and the size (weight) of the armour units. Iribarren (1949) in Spain was one of the pioneers, and then Hudson (1959). Since then, researchers and designers relied upon an estimation of waves at the site and the use of empirical formulae for the determination of the size of armour units. In many cases it was still a "trial and error" process, where the breakwater was designed based upon limited knowledge of the wave conditions, which in many cases resulted in a too weak design, and in other cases in overdesign. When damage occurred, a breakwater was repaired by adding more armour units, and thereby it became stronger and stronger if the rock or concrete blocks were large enough. Some of the earlier breakwaters with artificial units were armoured with cubes or rectangular blocks, and as for rock breakwaters, the repair is often relatively easy. It can be done by adding more armour units for reinforcement and strengthening. One example of such breakwater with blocks from 1930s is shown in Figure 1

Figure 1 Example of breakwater armoured with large rectangular blocks (Port of Algiers, Algeria).

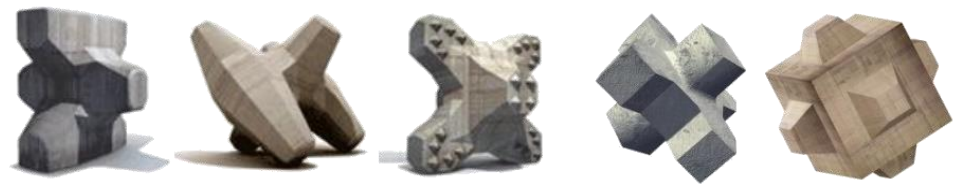
In the period between 2005-2010 the Cubipod® was developed at the Universitat Politècnica de Valencia by Professor J.M. Medina and others. The Spanish company SATO now holds the patent of the Cubipod®, which is a cube with 6 pods (stubs) sticking out on each of the six sides of the unit, see Figure 2 and Medina et al (2016).

Figure 2 Armour units: Accropode™ I, Core Loc™, Accropode™ II, XBloc® and Cubipod®

Cubipod® is bulkier and more robust than the other monolayer units (see Figure 2) and does not gain its hydraulic stability from interlocking. This can also be seen in the apparent porosity of an armour layer, which is approx. 40% for Cubipod®, but approx. 54-58% for the other units. Cubipod® is also the only unit where the patentee, SATO, is advocating/promoting their use in both one and two layers of the armour, see Cubipod Manual, Medina et al (2016). This manual presents the recommended  $K_D$  factors for the use in one and two layers, and somewhat surprisingly a  $K_D$  as high as 28 is presented for a two-layer solution for trunk sections. It appears that the  $K_D=28$  was derived from hydraulic model tests and corresponds to a situation with “initiation of destruction”, see Gomez-Martin et al. (2014). Hence, this very high  $K_D$  is inconsistent with the definition of  $K_D$  for practical breakwater design, which is based on “initiation of damage”. It is the authors opinion, a robust breakwater design should be based on “initiation of damage”, and it seems potentially misleading to present such a high  $K_D$  if the assumptions behind it are not clearly communicated, and without warning against using this  $K_D$  blindly. Otherwise, the unprepared and unexperienced designer may be misled into using such high and unsafe  $K_D$  values. For one-layer solutions, SATO recommends  $K_D=12$ , based on the normal definition as “initiation of damage”. In COWIs application of Cubipod® for the new Western Breakwater in Hanstholm (Denmark)  $K_D=11.7$  was documented by physical model tests for 22t high density Cubipods® in one layer (based on a design  $H_{1/3}=9.0\text{m}$  measured at the toe of the breakwater), see Lauridsen et al. (2023).

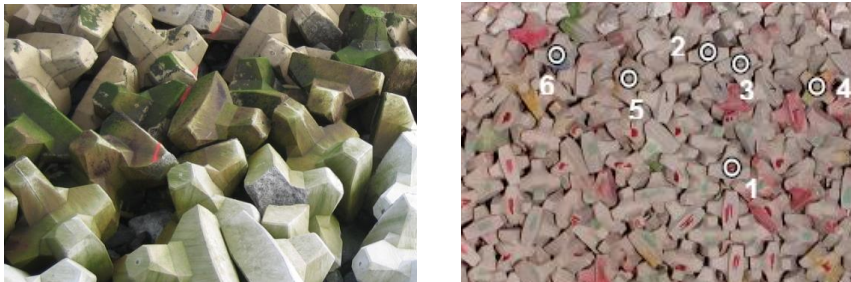
Figure 4 shows an example from a prototype with broken units and openings in the armour layer (left) and results from model tests of same structure with detection of rocking units (right).

Figure 4 Broken units in the prototype (left) and rocking units registered in model tests (right). Revetment with Accropode™ I (6.3 m<sup>3</sup>).

- First and foremost, model armour units in the model do not break as they may in the prototype. Assume a typical model test in scale 1:60. A model unit is then typically ~4 cm. It is very difficult to observe units exercising limited rocking and displacement during wave action. If a model unit is moving/rocking ~10% of the size of the unit, or 4 mm (~25 cm in prototype) it is extremely difficult to detect in a model even using video and overlay photos before and after testing.

- Often model armour units may rock during a test and be in the same position after the test, so it is not detected by still photos. Further, the rocking occurs during severe run-up or run-down and the armour layer is covered with waves and turbulent water with air entrainment. This often makes the water unclear, and it is virtually impossible to observe rocking units.

- Some of the observed damage to actual breakwaters can only be explained by accepting that such small movements and rocking may introduce excessive stress in the prototype units, which may break, even for wave conditions below the design event. However, the rocking criterion defined by the patentees of the interlocking units is for design wave conditions only and not for more frequent wave conditions. These more frequent events may in fact be equally relevant when considering breakages due to rocking in view of imperfections in placement and settling (re-compacting) of the armour units after construction.

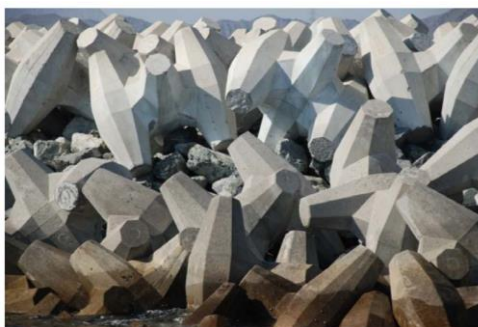
A new example with broken Core Loc™ is shown by Hendrikse (2014), see Figure 7. Here, it is apparent that the armour on the slope has settled due to wave action while the armour on the crest is in place, and a horizontal rift has opened in the armour layer.

Figure 7 Movement of Core Loc™ units with large settlements (Hendrikse et al., 2014).

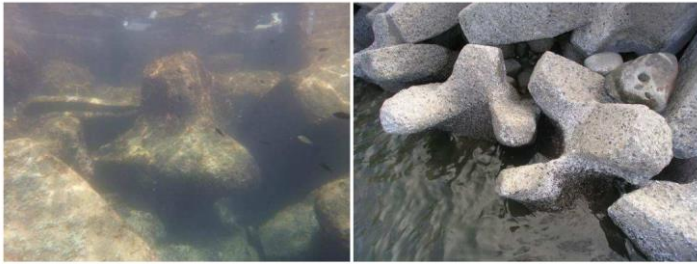
Figure 8 shows an example where the Accropode™ type I units have been subject to significant wear and tear by mechanical action of sand and smaller rocks. It is therefore important for a project that the toe and berm are designed so that other rocks cannot move up onto the lower part of the armour layer. Sometimes armour units are displaced completely out of profile as seen in the example shown in Figure 9. It is not known whether in this case the displacement was due to bad placement during construction or due to extraction by waves of the unit from its original position. Other times armour units may be extracted completely out of the armour layer and settle on the seabed as shown in the example in Figure10.

Figure 8 Accropode™ I with unit not interlocked and wear and tear of the units from movement of smaller rocks (Giraubel C. et al., 2014).

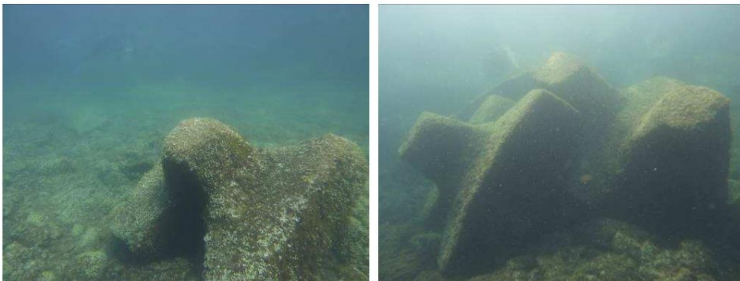
Figure 10 Example of single extracted unit on seabed (Giraubel C. et al, 2014).
